Capitol Annex Photos

This document highlights some of the major deficiencies in the Capitol Annex. Further details regarding the deficiencies can be found on the referenced page numbers in the CSHQA Capitol Annex Report. Higher resolution photos can be found in the press packet flash drives and on the Annex website at <http://annex.assembly.ca.gov/>.

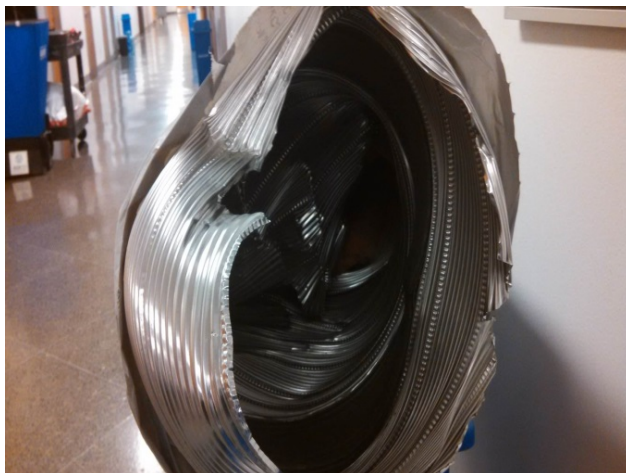
Aging HVAC Systems (Damaged Duct)

The Capitol Annex functions with an aging HVAC system that was intended to support the occupants of a part-time Legislature. The existing HVAC system struggles to maintain indoor air quality and during times of high occupancy, humidity levels climb rapidly and noticeably on upper floors. More information on this topic can be found on pages 10, 21, 26, 57, and 71 of the report.

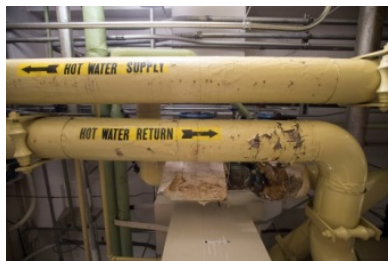
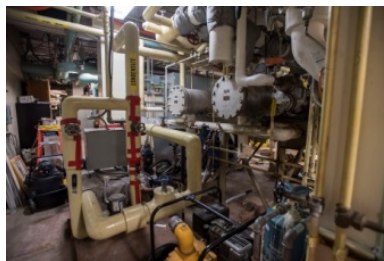
Aging Mechanical Systems (Boiler Room and Pipes)

The Capitol Annex functions with an aging mechanical system that was largely built from materials commonly used in the 1950's. Over the years, the failing plumbing system has led to several leaks that have caused damage at the point of the leak and to the floors below. Pictured here is the boiler room (top left, top right, and bottom left) and pipes (bottom right). More information on this topic can be found on pages 10, 26, 27, 57, and 71 of the report.

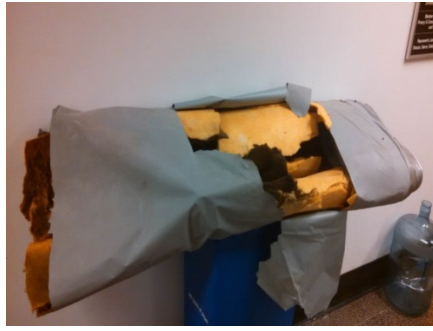
Aging Systems (Damaged Insulation)

Modern building codes have insulation requirements that far exceed the existing insulation in the Annex. Aging and damaged insulation fails to retain temperatures as intended, leading to more energy use. The energy inefficiency of the Annex is unnecessarily costly and does not align with California's sustainability goals. More information on this topic can be found on pages 10, 26, 57, and 71 of the report.

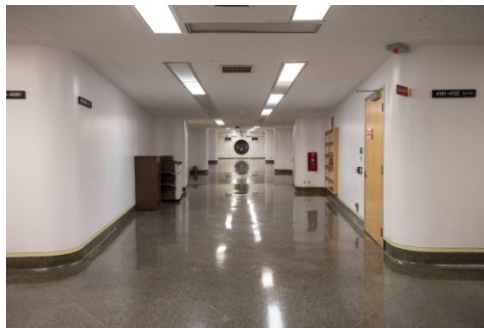
Corridors to Large Hearing Rooms

The corridors to the Capitol's largest hearing rooms have shiny and sloping floors that were designed before the Americans with Disabilities Act was signed into law. The slope steepness of the floor exceeds the maximum allowable limits for walking surfaces and ramps, and the corridor lacks handrails required under modern accessibility standards. Shiny floors cause greater concern to the visually impaired since they often cannot see the floor edge or discern the texture and slope of a floor surface. More information on this topic can be found on pages 10-15, 52, 53, and 71 of the report.

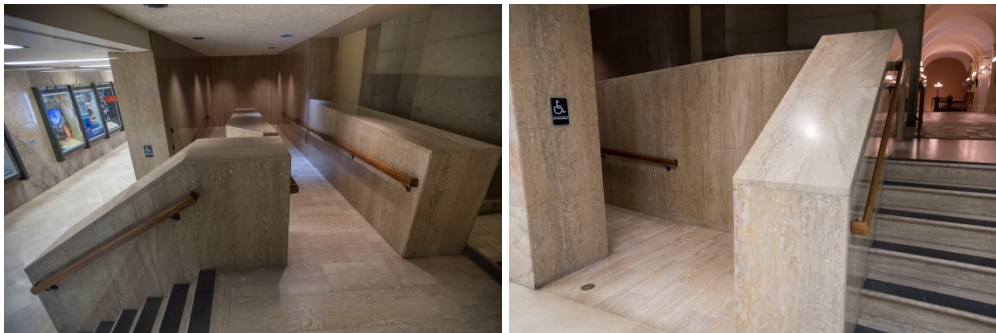
Floor Alignment and Accessibility

Entryways to the Capitol are mainly located on the first floor of the Annex, which does not align with the first floor of the historic West Wing. Long and narrow ramps veering off the main path, post-applied lifts, and steps through the common route of foot traffic place additional burdens on those requiring accessibility assistance. More information on this topic can be found on pages 10-15, 52, 53, and 71 of the report.

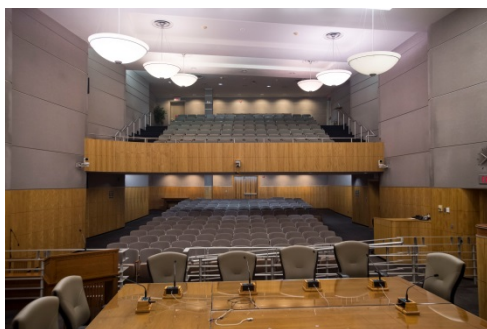
Inaccessible Hearing Room (Rm 4203)

The Capitol's largest hearing rooms were built before modern accessibility standards were signed into law. Room 4203 lacks required wheelchair seats, companion seats and semi-ambulant seats making it difficult for those with accessibility needs to easily participate in the democratic process. On the first floor, the slope steepness of the floor exceeds the maximum allowable limit for ramps and lacks required handrails. At the balcony level, handrails are installed but the lack of ramps makes these seats inaccessible to many. More information on this topic can be found on pages 10-15, 52, 53, and 71 of the report.

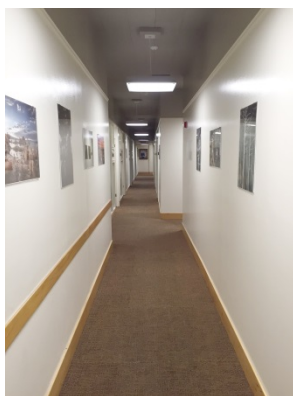
Narrow Corridors (Governor's Suite)

Narrow corridors throughout the Annex are not compliant with modern codes and affect security and emergency preparedness in the Capitol. They also place additional burdens on those who require accessibility assistance. More information on this topic can be found on pages 10-15, 52, 53, and 71 of the report.

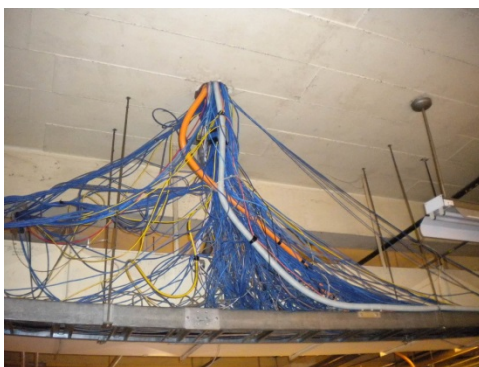
Undersized Electrical Infrastructure

The existing electrical infrastructure is undersized and is not compliant with current energy efficiency requirements for buildings. It predates modern office equipment needs and, in many ways, is supporting modern electronics on a backbone of the 1952 infrastructure. More information on this topic can be found on pages 10, 28, 29, 58, and 71 of the report.
