## Capitol Annex Photos

This document highlights some of the major deficiencies in the Capitol Annex. Further details regarding the deficiencies can be found on the referenced page numbers in the California State Capitol Annex Project Planning Study.

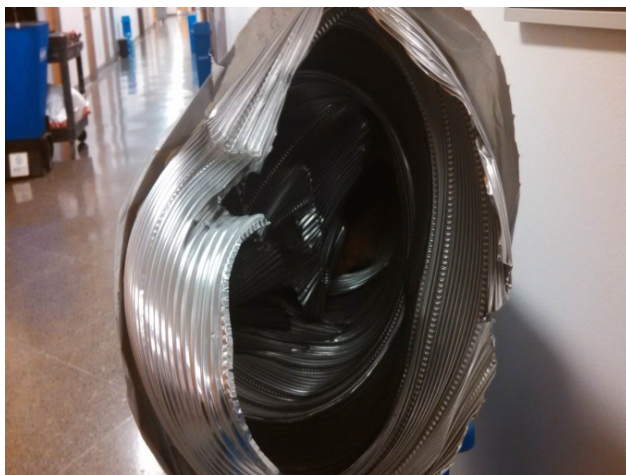
**Aging HVAC Systems (Damaged Duct)**

The Capitol Annex functions with an aging HVAC system that was intended to support the occupants of a part-time Legislature. The existing HVAC system struggles to maintain indoor air quality and during times of high occupancy, humidity levels climb rapidly and noticeably on upper floors. More information on this topic can be found on pages 10, 21, 26, 57, and 71 of the report.

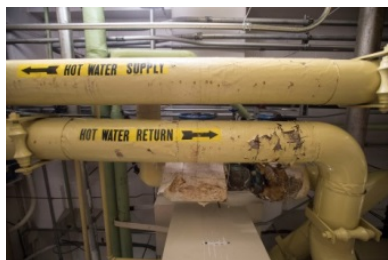
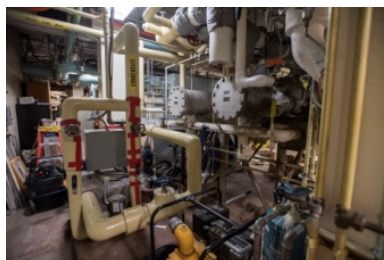
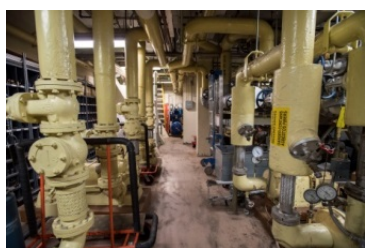
**Aging Mechanical Systems (Boiler Room and Pipes)**

The Capitol Annex functions with an aging mechanical system that was largely built from materials commonly used in the 1950's. Over the years, the failing plumbing system has led to several leaks that have caused damage at the point of the leak and to the floors below. Pictured here is the boiler room (top left, top right, and bottom left) and pipes (bottom right). More information on this topic can be found on pages 10, 26, 27, 57, and 71 of the report.

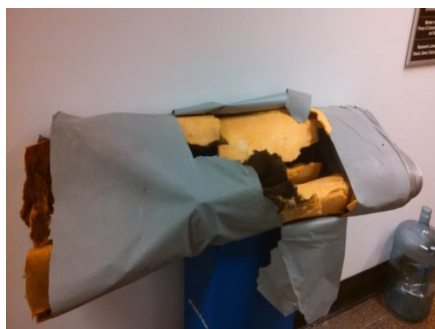
### **Aging Systems (Damaged Insulation)**

Modern building codes have insulation requirements that far exceed the existing insulation in the Annex. Aging and damaged insulation fails to retain temperatures as intended, leading to more energy use. The energy inefficiency of the Annex is unnecessarily costly and does not align with California's sustainability goals. More information on this topic can be found on pages 10, 26, 57, and 71 of the report.

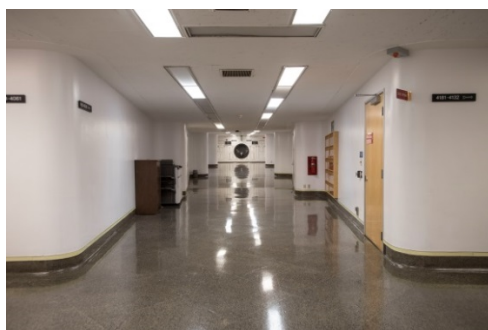
### **Corridors to Large Hearing Rooms**

The corridors to the Capitol's largest hearing rooms have shiny and sloping floors that were designed before the Americans with Disabilities Act was signed into law. The slope steepness of the floor exceeds the maximum allowable limits for walking surfaces and ramps, and the corridor lacks handrails required under modern accessibility standards. Shiny floors cause greater concern to the visually impaired since they often cannot see the floor edge or discern the texture and slope of a floor surface. More information on this topic can be found on pages 10-15, 52, 53, and 71 of the report.

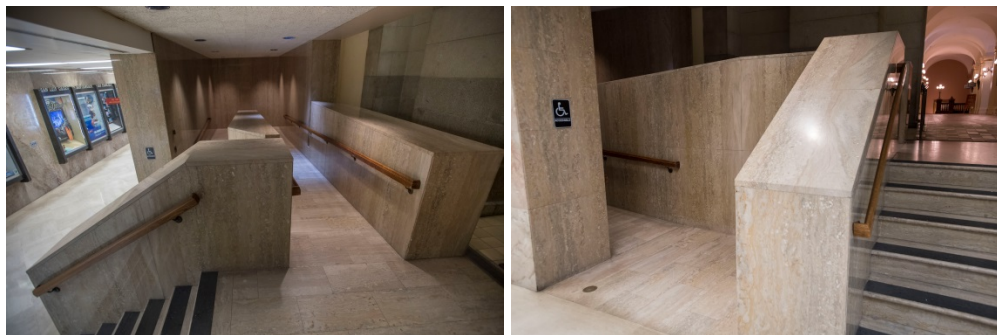
### **Floor Alignment and Accessibility**

Entryways to the Capitol are mainly located on the first floor of the Annex, which does not align with the first floor of the historic West Wing. Long and narrow ramps veering off the main path, post-applied lifts, and steps through the common route of foot traffic place additional burdens on those requiring accessibility assistance. More information on this topic can be found on pages 10-15, 52, 53, and 71 of the report.

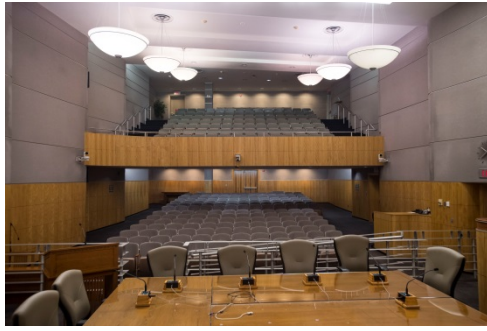
### **Inaccessible Hearing Room (Rm 4203)**

The Capitol's largest hearing rooms were built before modern accessibility standards were signed into law. Room 4203 lacks required wheelchair seats, companion seats and semi-ambulant seats making it difficult for those with accessibility needs to easily participate in the democratic process. On the first floor, the slope steepness of the floor exceeds the maximum allowable limit for ramps and lacks required handrails. At the balcony level, handrails are installed but the lack of ramps makes these seats inaccessible to many. More information on this topic can be found on pages 10-15, 52, 53, and 71 of the report.

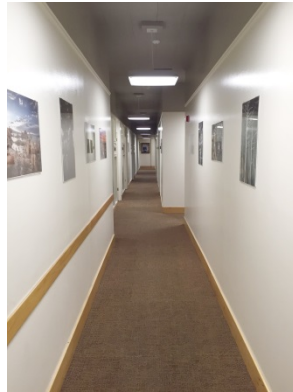
### **Narrow Corridors (Governor's Suite)**

Narrow corridors throughout the Annex are not compliant with modern codes and affect security and emergency preparedness in the Capitol. They also place additional burdens on those who require accessibility assistance. More information on this topic can be found on pages 10-15, 52, 53, and 71 of the report.

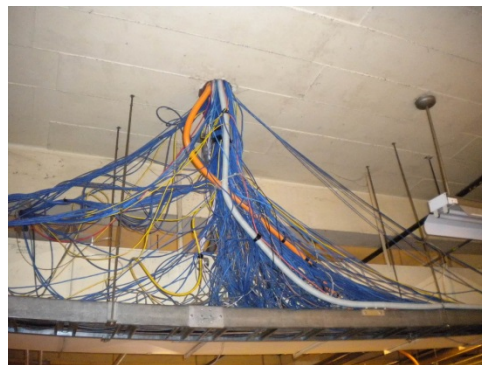
### **Undersized Electrical Infrastructure**

The existing electrical infrastructure is undersized and is not compliant with current energy efficiency requirements for buildings. It predates modern office equipment needs and, in many ways, is supporting modern electronics on a backbone of the 1952 infrastructure. More information on this topic can be found on pages 10, 28, 29, 58, and 71 of the report.
